Manhole Inspection Summary

Manhole # S31EE_014MH

Insp Date: **1/26/07 11:10 AM**

Location Address: **247 DOLPHIN ST**

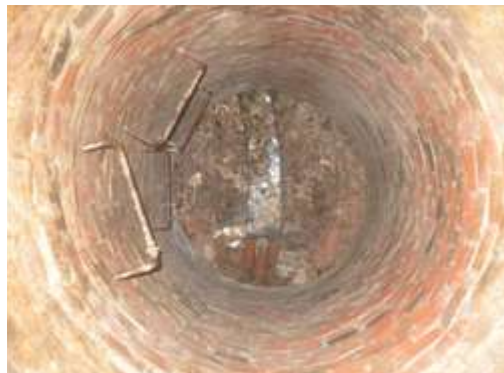
Top View

Evidence of surcharge - Bench debris.
Channel debris.

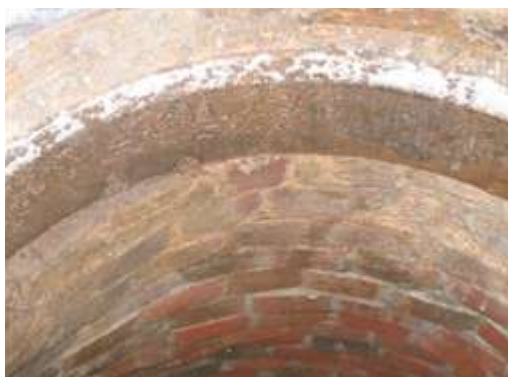
Defect

Frame leaks. Adjustment and Corbel
infiltration.

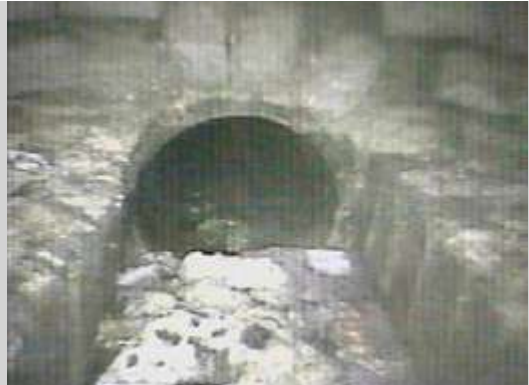
8 in. Circular Gravity Sewer Pipe Out @ 12 O'Clock

Invert Depth: **11.31** (ft.) Flow Characteristics: **Slow**

Deposits: ☐ None ☒ **Mud** ☐ Sludge ☒ **Debris** ☒ **Grease**

Silt Depth: **2** (in.) Deposits Extent: **Medium**

Infiltration: **Evidence** Pipe Seal Cond: **Unknown**

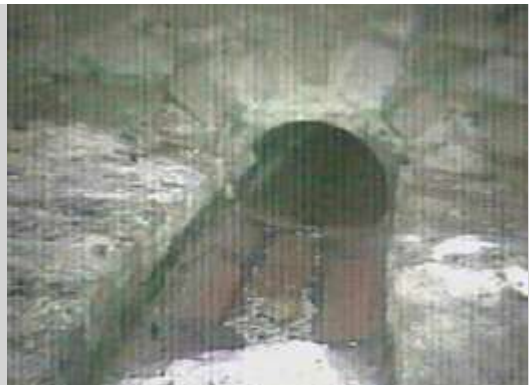
8 in. Circular Gravity Sewer Pipe In @ 7 O'Clock

Invert Depth: **11.00** (ft.) Flow Characteristics: **Slow**

Deposits: ☐ None ☐ Mud ☐ Sludge ☐ Debris ☒ **Grease**

Silt Depth: **0** (in.) Deposits Extent: **Light**

Infiltration: **Evidence** Pipe Seal Cond: **Unknown**
